## **THESIS**

**IMAGING GALLIUM NITRIDE HIGH ELECTRON  
MOBILITY TRANSISTORS TO IDENTIFY POINT  
DEFECTS**

March 2014

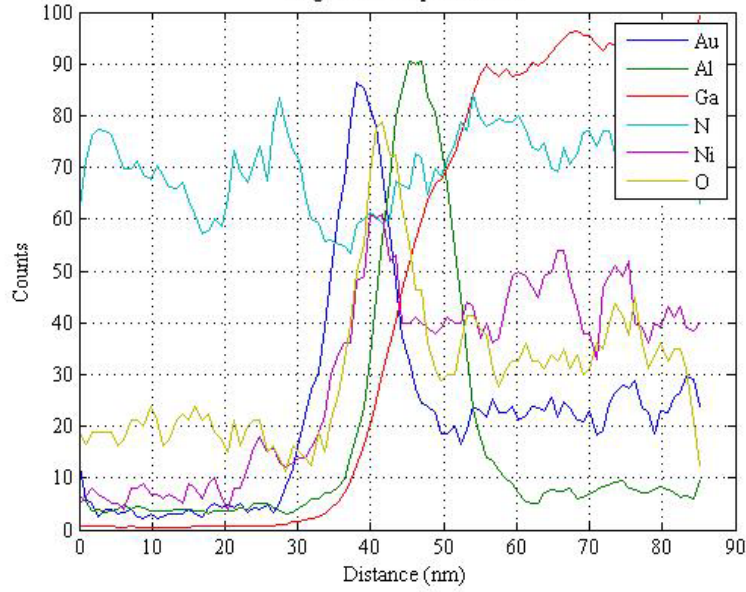
Figure 59. Line scan data of the degraded Ni dip line scan depicting the presence of each element analyzed.

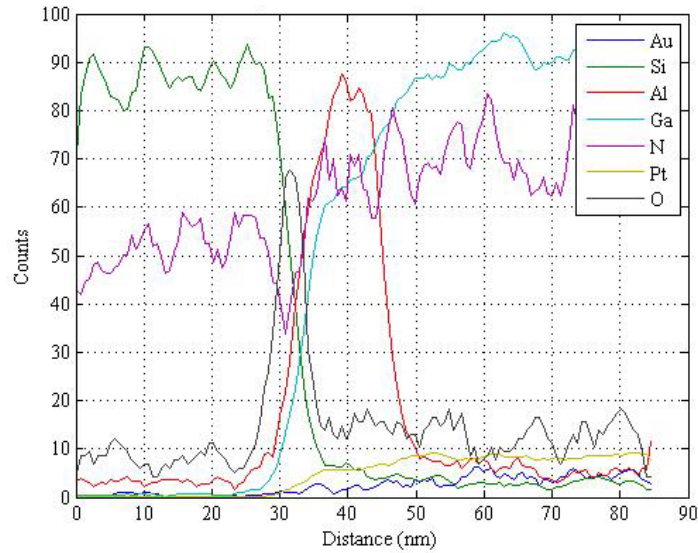
Figure 60. Line scan data of the degraded Ni active layer line scan depicting the presence of each element analyzed.

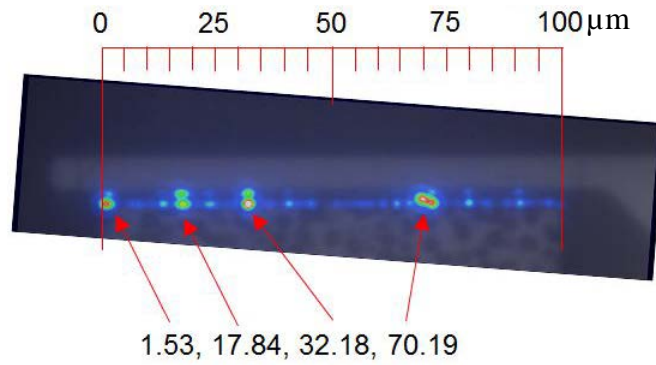
Figure 61. Electroluminescence after stressing on the failed Nickel gated HEMT. The arrows correspond to the distance across the gate in  $\mu\text{m}$  beginning at the edge of the source indicating areas of higher intensity.

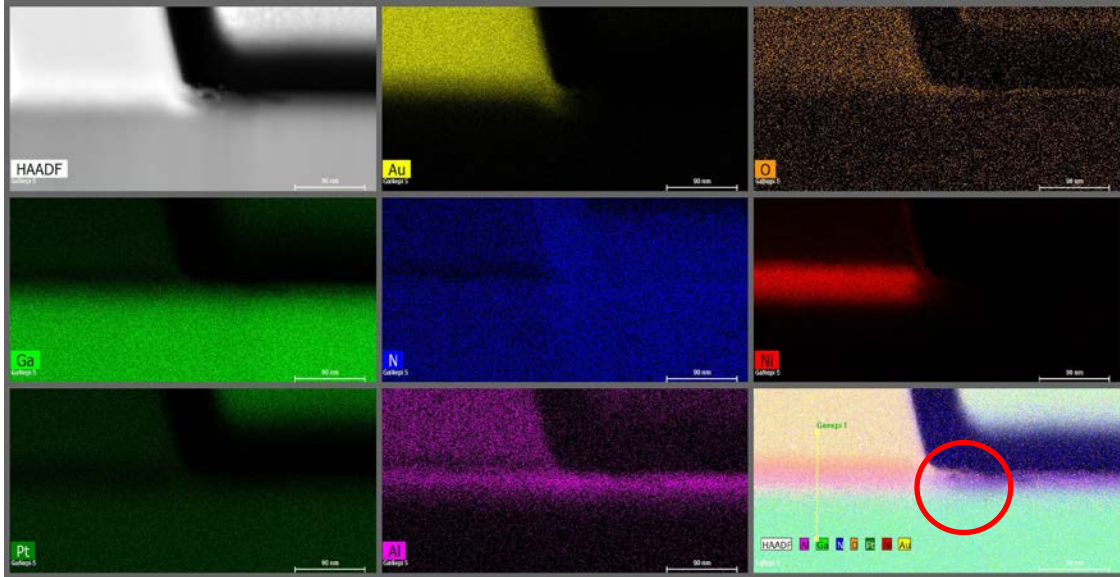
Figure 62. Elemental scans from the EDS for the failed Nickel gated device. The top left image is the HAADF followed by the seven singular elemental pictures (Au, O, Ga, N, Ni, Pt, and Al), ending with the composite picture of those seven elements.

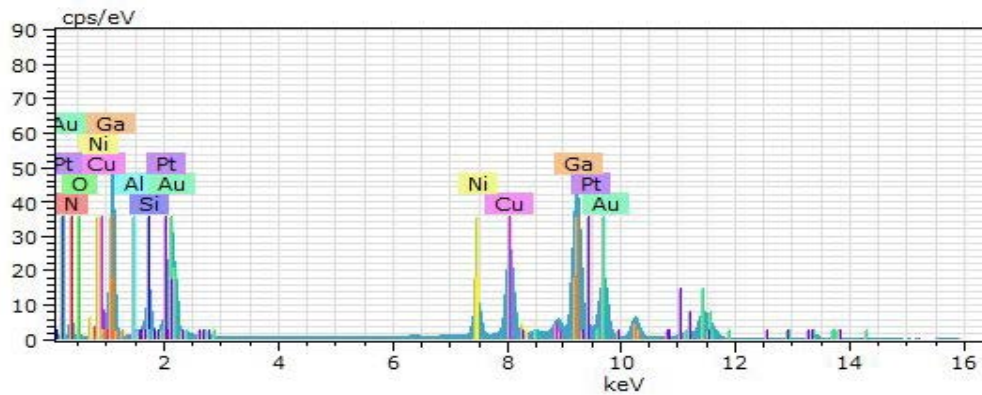
Figure 63. Elemental spectrum display of electron volts versus photon counts of the failed Ni sample. The peaks in the spectrum correspond to individual elements present in imaged area.

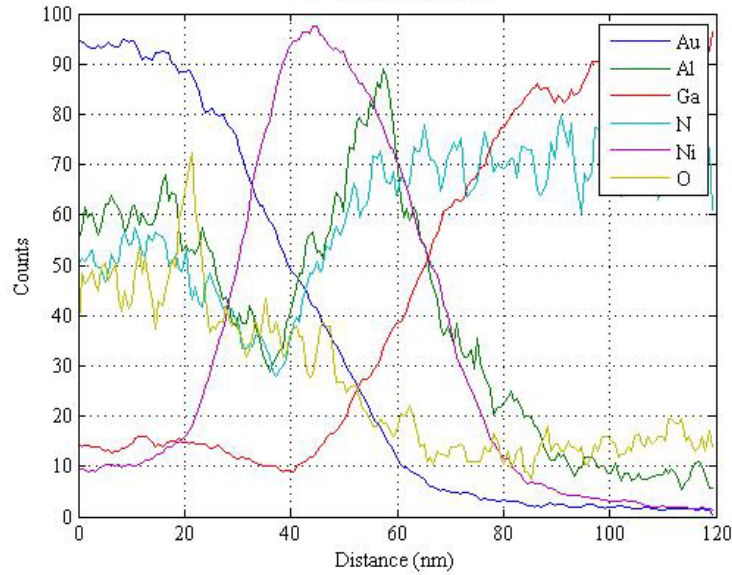
Figure 64. Line scan data for failed Ni gate line scan depicting the presence of each element analyzed.

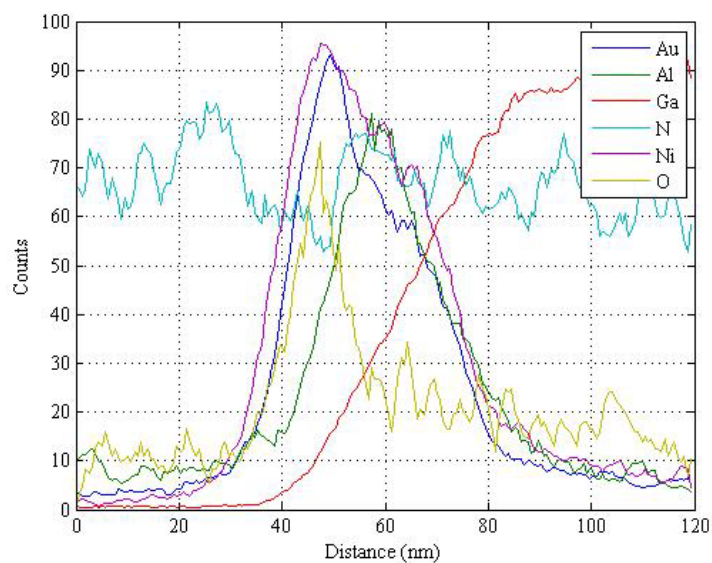
Figure 65. Line scan data of the failed Ni foot line scan depicting the presence of each element analyzed.

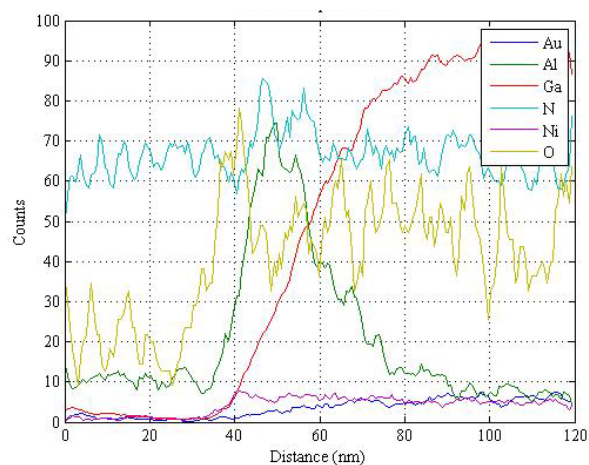
Figure 66. Line scan data for the failed Ni dip line scan depicting the presence of each element analyzed.

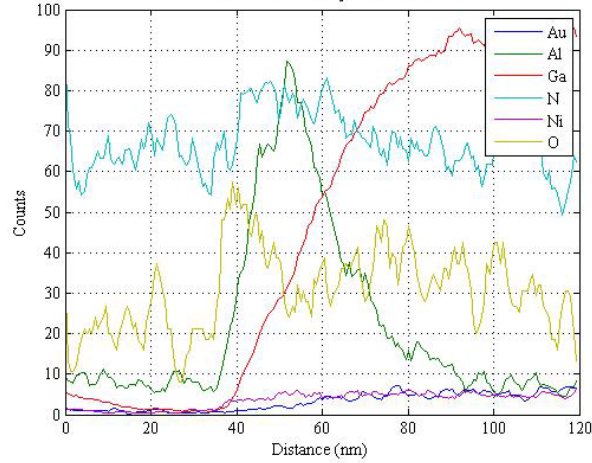
Figure 67. The line scan data for the failed Ni active layer line scan depicting the presence of each element analyzed.

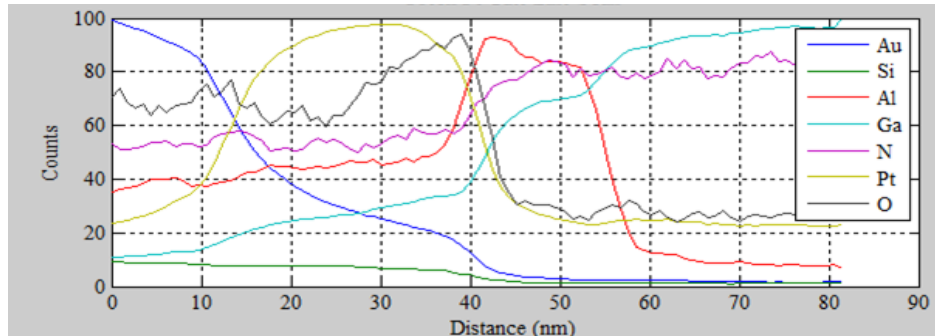
Figure 68. Fresh Pt gate line scan data.

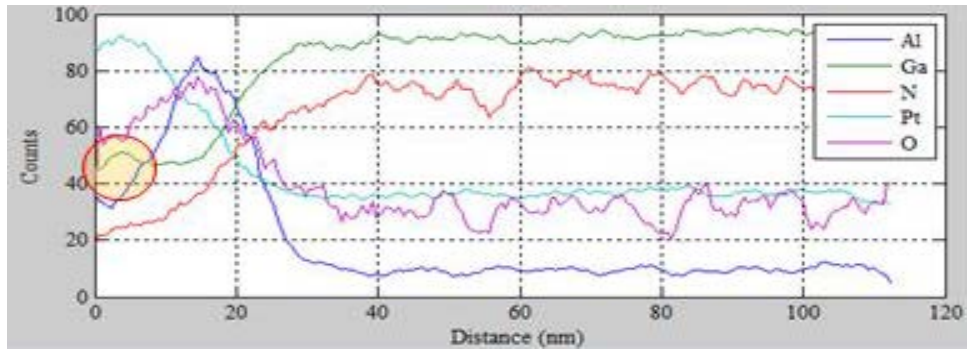
Figure 69. Epitaxial line scan with GaN cap present in highlighted area.
